"Full" Reserve Study

**Rolling Hills CSD
El Darado Hills , CA**

**Report #: 35000-0
For Period Beginning: July 1, 2018
Expires: June 30, 2019**

Date Prepared: August 29, 2018

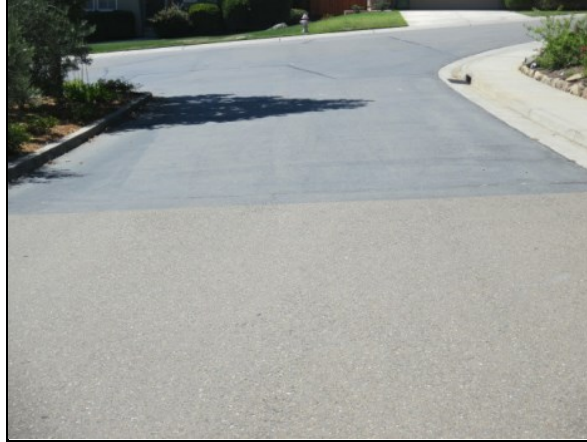
There were isolated areas throughout the surfaces that showed areas of cracking and minor block cracking noticed. We recommend having surface sealed and repaired as directed in component #203; regular cycles of seal coating are recommended for maximum design life. Continue to monitor asphalt and adjust future funding as necessary.

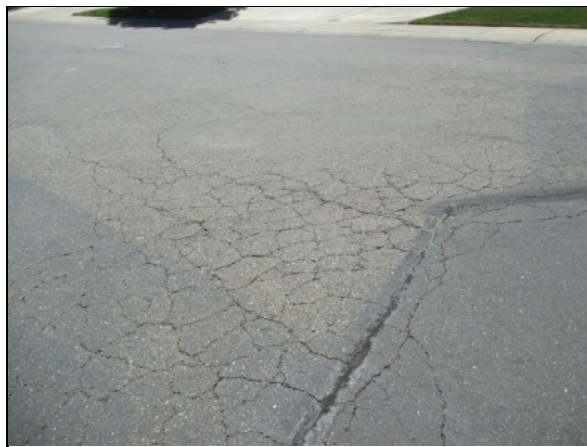
Comments: Seal coat is thin exposing the aggregate base. There is a small section at the entrance that is damaged showing block cracking. Regular cycles of seal coating, along with any needed repairs, has proven to be the most cost effective program for the long-term care of asphalt. Seal coating protects against damaging weather elements, while bridging small surface cracks and maintaining a uniform appearance over the inevitable patching and repairs needed in future years. This component provides an allowance to seal and repair (2%) of the roads every 7 years.

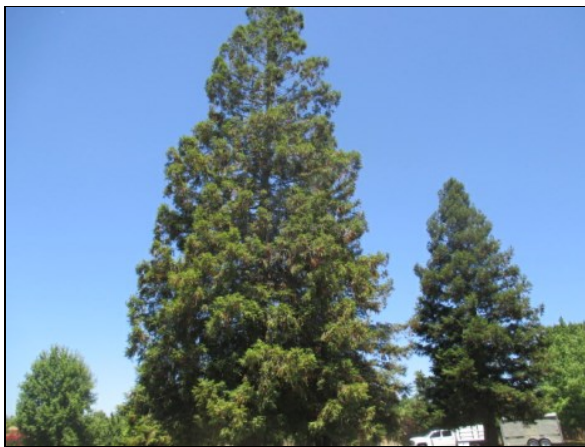
Comments: This component may be utilized for larger tree removal/trimming projects which do not occur on an annual basis. If the community has not already done so, consult with a qualified arborist for a long term plan for the care and management of the trees within the community, balancing aesthetics with protection of association assets. Reserve funding recommend at level indicated below for periodic, larger tree removal/trimming needs.

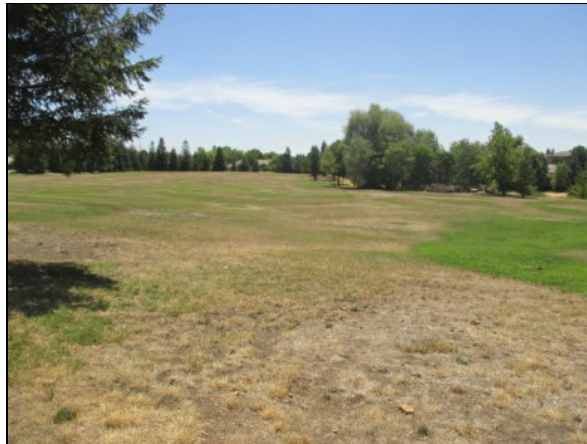
Comments: We were informed by the client that the community will renovate the Stonebriar park in the future. Renovations include new lawn, irrigation, drainage, etc. We recommend consultation with a licensed professional to help establish a viable maintenance plan. This component sets up a rotating allowance for landscape renovations around the open spaces and parks.
